# Corrosion of Roof Truss Gusset Plates in Farm Buildings

## Factsheet

ORDER NO. 10-071 AGDEX 714 SEPTEMBER 2010

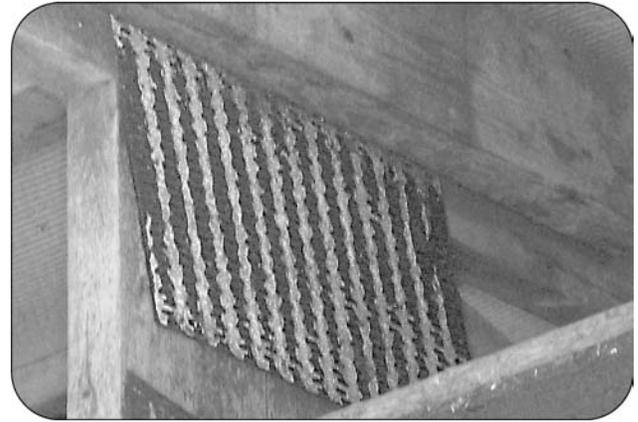
**Figure 2.** This gusset plate is beginning to show signs of rust and deterioration.

Figure 2 shows the degradation that can occur when the roof trusses are included in the environmental air space of a building — the gusset plate is beginning to rust. In contrast, Figure 3 shows a gusset plate that has been in place for a longer period of time, but only used in an equipment storage building. This joint is still in good condition because it has not been exposed to corrosive environmental conditions.

Truss plates often show the greatest deterioration near the building air exchange openings, typically at the heel and peak joints of the truss — the areas of greatest air mixing and temperature change, producing high humidity and condensation problems. Unfortunately, these are also very critical joints in the structural integrity of the truss.

- If the truss deterioration is minor, employ one or more of the prevention procedures outlined above to halt further corrosion.
- If the deterioration is more severe, consider a structural repair. Have a consulting engineer conduct an assessment and repair specification. The Ontario Building Code requires roof systems to be engineered.

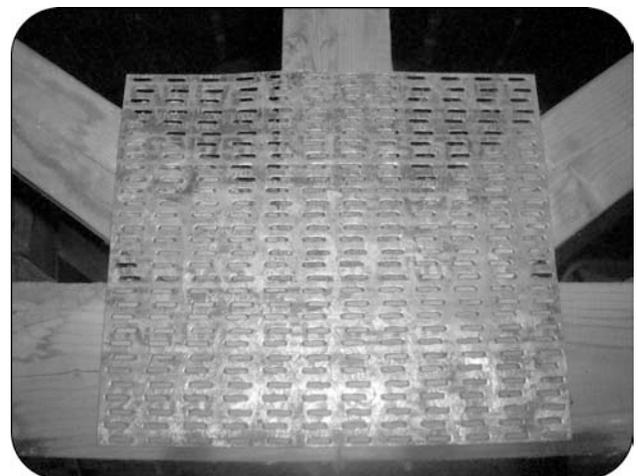
**Figure 3.** An older gusset plate still in good repair.
